MAINTENANCE OF THE N47 INTERNAL-COMBUSTION DIESEL ENGINE

TAMÁS FEKETE

Abstract: The N47 engine debuted in March 2007 in the facelifted BMW 1 Series E87 and E81 and was also available in the BMW 1 Series E82 and E88, which were introduced the same year. The N47 engine replaced the M47 engine that had been in production for 8 years. The M47 construction underwent several modifications, so the injection system was changed, the cylinder head now consists of two parts, and the engine block is made of aluminium. Two main versions of the N47 engine are known: N47D16 (1.6 L) and N47D20 (2.0 L). In the case of both versions, several models with different performances were born. After the distribution of BMW passenger cars equipped with the N47D20 engine, it received a lot of negative criticism due to malfunctions. In this article, I would like to present the maintenance of the engine, which can be used to avoid the failure of passenger cars equipped with the N47D20 diesel engine with huge material damage.

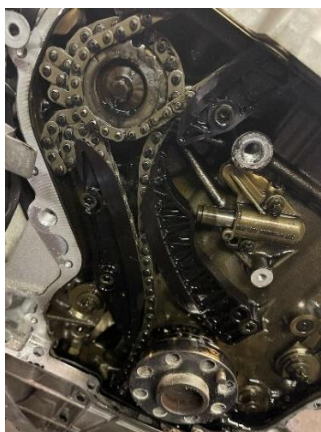
The N47 engine family is prone to excessive timing chain wear and premature failure [BBC.co.uk: BMW deny engine failures are due to manufacturing fault, 2013]. A rattling noise from the rear of the engine indicates the condition. Timing chain failure may require engine replacement or costly repairs. The units most seriously affected and in need of the greatest repair were between 1. 3. 2007 and 5. 1. 2009 was produced [1]. However, there have been frequent reports of timing chain failure (*Figure 1*) in BMW 1, 3 and 5 series diesel engines manufactured from 2004 to at least 2011. The failure occasionally resulted in the engine stalling dangerously while the vehicle was being driven sometimes at relatively high speeds. A “Quality Enhancement” was issued by BMW for some, but not all vehicles, but has since been discontinued.

Figure 1. Timing chain failure (break)

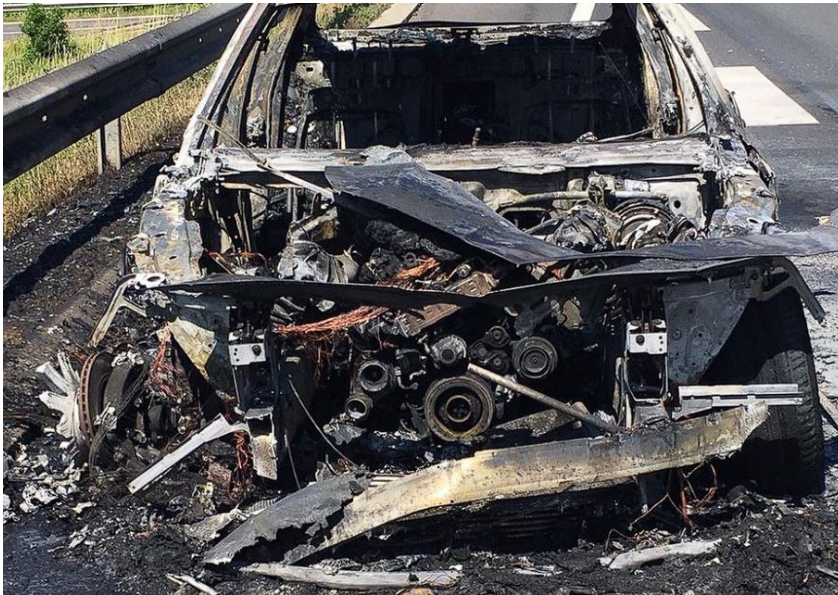
If the vacuum hose supplying the EGR (Exhaust Gas Recirculation) cooler bypass valve gets a hole rubbed in it, or breaks down from old age and oil spray, the EGR cooler will not get bypassed during the engine warmup period. This causes excessive build-up in the cooler matrix, and when the engine warms up these solid chunks of build-up can detach from the EGR cooler and get sucked into the plastic intake tube, melting holes in the intake tube, causing a massive boost leak and in very rare cases an engine fire (*Figure 2*). BMW has issued a recall to over 1.6 million vehicles in 2018 for the EGR issues (Braithwaite-Smith G.: Massive BMW diesel engine recall is expanded, *Motoring Research*, 2019).

Figure 2. Vehicle with N47 engine after catching fire

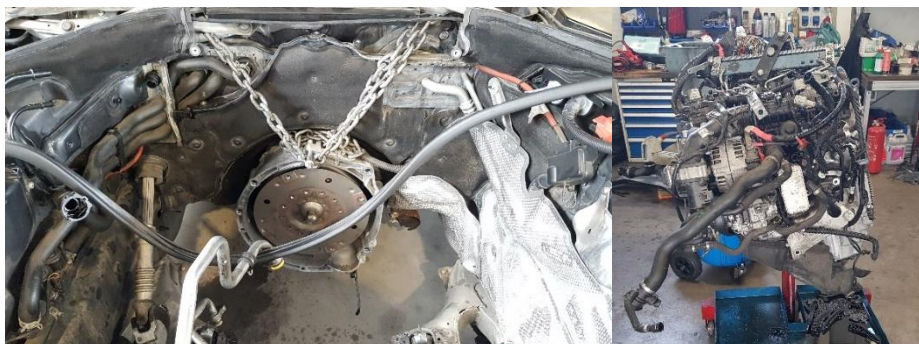
Figure 3. *The engine compartment without the engine and the removal of N47 engine*

The first and most important thing is to replace the timing chain and its associated components (sprockets, tensioners, etc.). Since the timing chain is located at the rear of the N47 engine, it is recommended to remove the engine block for professional inspection and repair work (*Figure 3*).

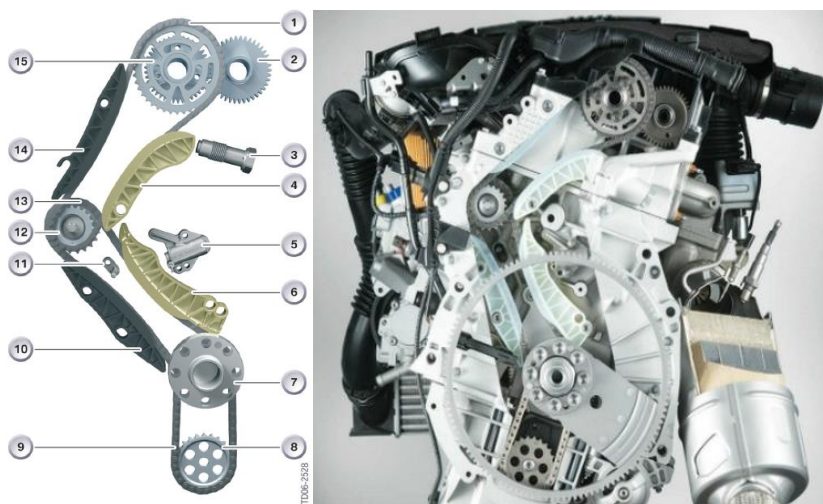
Timing chain elongation can also be determined from the condition of the tension cartridges (*Figure 4*).

Figure 4. *The timing chain system (Tumblr, N47 timing chain, source of a picture)*

Since the engine block must be disassembled for the inspection, replacement is recommended even if the timing chain is still in good condition. If the timing chain is broken in the block, further tests are suggested to determine the exact damage.

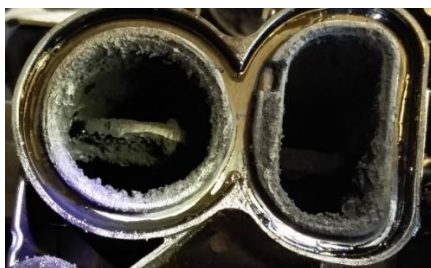
Figure 5. Oily soot deposits in the plastic intake pipe

The leakage of coolant caused by the EGR is only a small element in the set of errors. The first and biggest problem is that the plastic intake manifold, like all direct injection engines, gets oily soot. Only the second stage is the failure of the EGR cooler. If this does not cool the recirculated gases enough, they will easily ignite the deposits in the intake line, which are already at the flash point. Then, due to the turbo pressure, the glowing oil and soot melt the plastic intake pipe. Once it is pierced, it is just a matter of luck as to what the resulting stabbing flame will achieve (0).

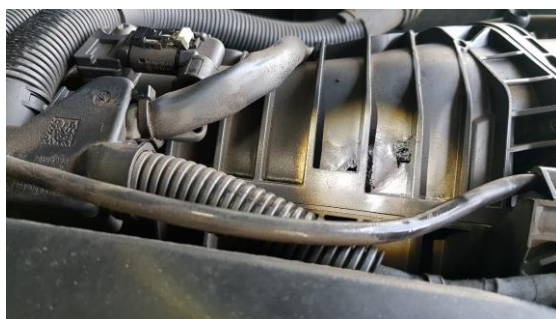
Figure 6. Melting of the cover on the engine as a result of the puncture of the intake pipe

If the complex error of the EGR system occurs on the highway in the summer, the vehicle will most likely catch fire.

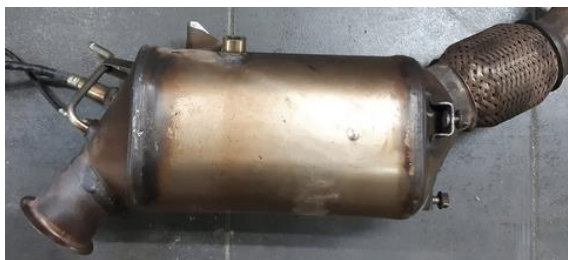
Figure 7. Diesel Particulate filter

The particulate filter (*Figure 7*), which collects the soot produced by the car's engine, is located directly on the right side of the cylinder bank. The filter must be burned out at certain intervals. This is solved by burning the excess diesel fuel added to the engine, the process starts while driving, typically when driving on the highway. The car does not indicate anything, the driver has no special task. However, the particle filter heats up to a temperature of 600 degrees, and if it has already been punctured, a piercing flame is created through the hole, which easily ignites the surrounding plastic coverings of the engine compartment. There are several of these, the N47D20 is heavily coated from above and below. Based on the experience so far, the punctured filter, which will certainly occur over time, can also cause the car to catch fire.

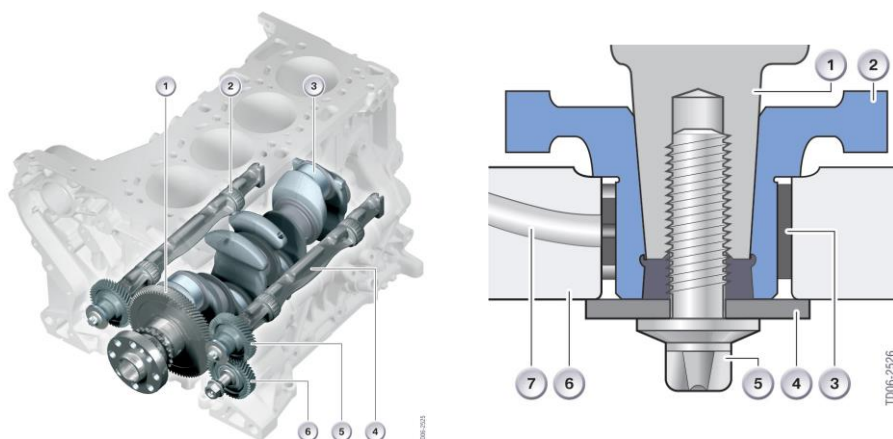
As previously mentioned, the balancing shafts (*Figure 10*) of the N47 engine are located inside the crankcase. They are inserted from the front. It is advisable to check the wear of the bushings by moving the balancing shafts, as it can cause strong vibrations, which can lead to further engine failure. It is advisable to check the wear of the bushes by moving the balancing shafts, as it can cause strong vibrations, which can lead to further engine failure.

Figure 10. The balancing shafts and the bush (denoted with number 3) [2]
