Design of Machines and Structures, Vol.4, No. 1 (2014), pp. 105–115.
https://doi.org/10.32972/dms.2014.011

LIFETIME ANALYSIS OF ROLLING ELEMENT BEARINGS

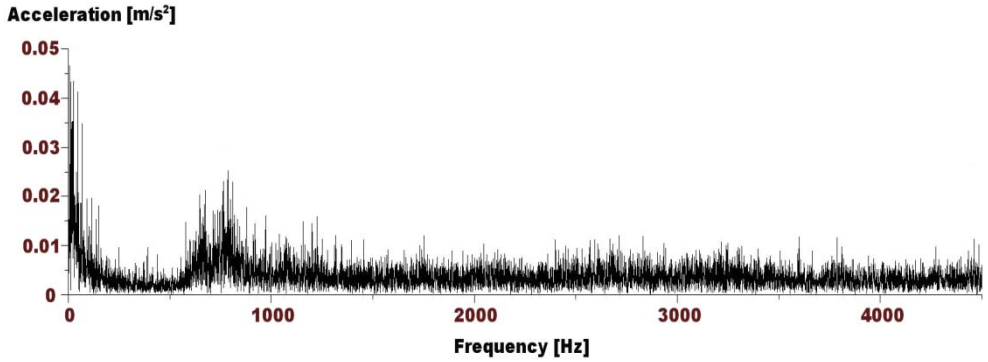
Figure 5: Vibrations spectrum at 23 operating hours

Figure 5 shows the nature of vibrations after 23 operating hours. During this period, the bearing was running safely.

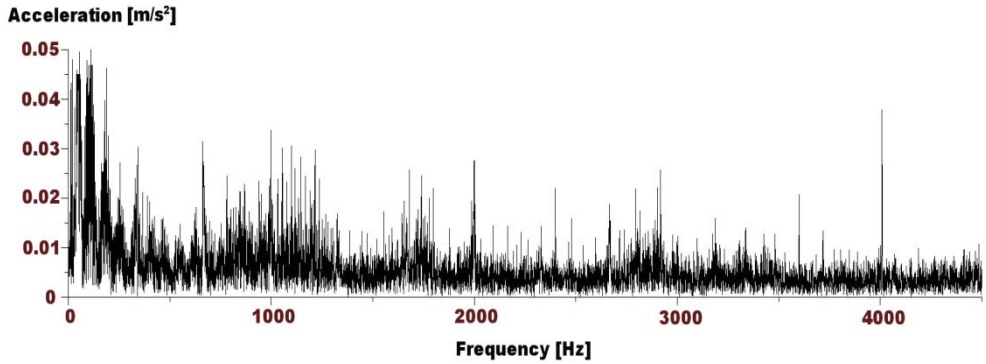
Figure 6: Vibrations spectrum at 70 operating hours

Figure 6 shows the nature of vibrations after 70 operating hours. It is conspicuous that the acceleration values have increased substantially at this bearing lifetime period.

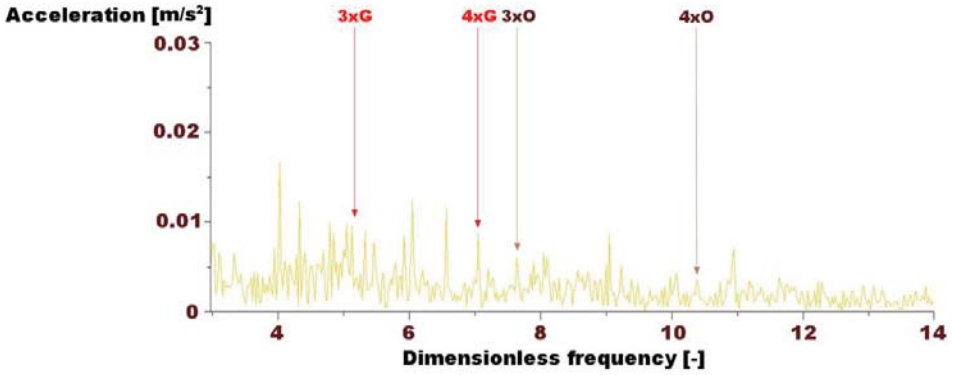
Figure 7: Vibrations spectrum with bearing failures at 36 operating hours

Some bearing frequencies appeared after 36 operating hours, which illustrated in Figure 7. The marking of the frequency codes are realized according to the abbreviations of Table 2.

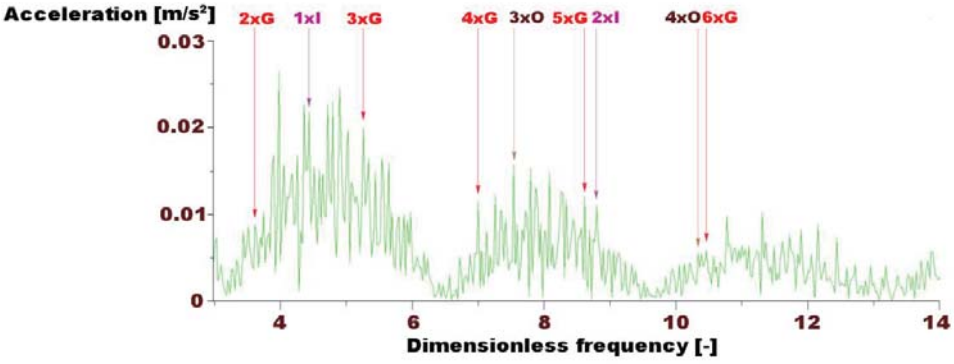
Figure 8: Vibrations spectrum with bearing failures at 60 operating hours

Figure 8 shows some bearing failures grew after 60 operating hours.

It is conspicuous that the passage of time the acceleration values grew materially. It is also apparent, that more and higher upper harmonic frequencies appeared as the time progressed.

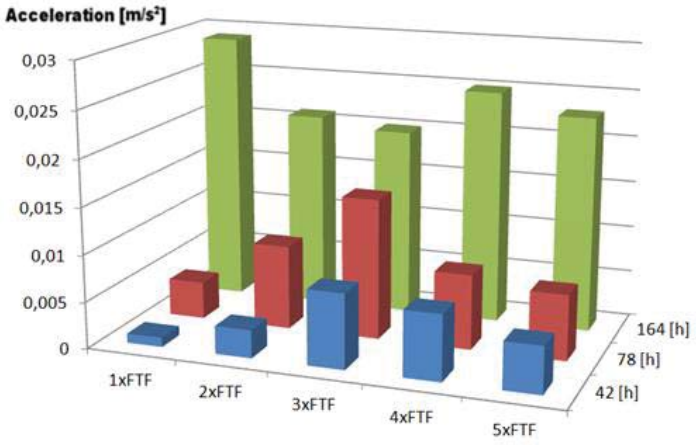
Figure 9: Cage frequency changes parallel the operating hours

The evaluation of the experiments, it was concluded that the Ball Spin Frequency and the Fundamental Train Frequency (frequency of the cage) give the most striking change. The following figures (Figure 9 and Figure 10) show the change of these frequencies and upper harmonic frequencies parallel with the operating hours.

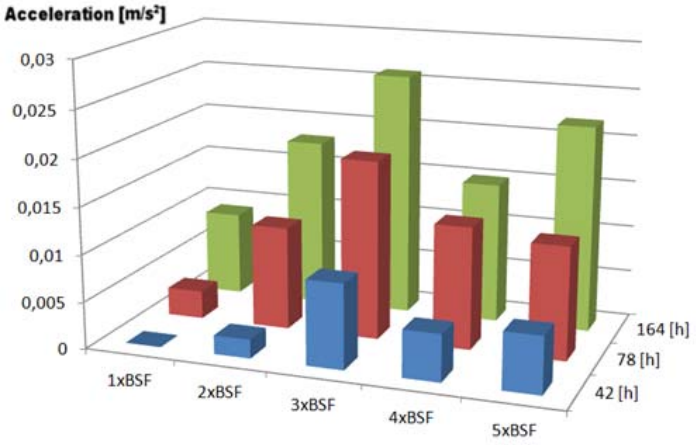
Figure 10: Ball Spin Frequency changes parallel the operating time

The bearing failure frequency peaks became well separable at the boundary of the basic bearing life.

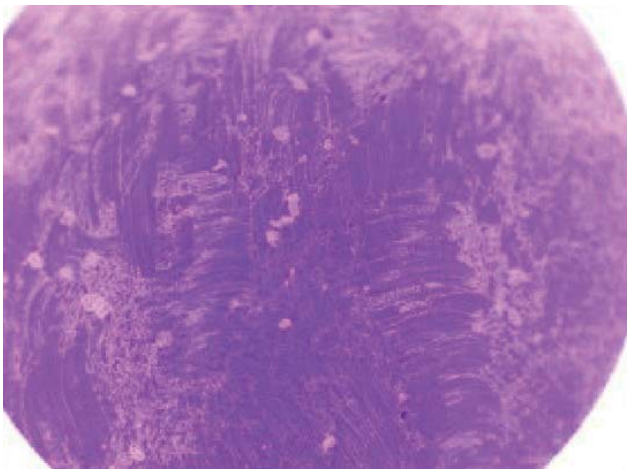
Figure 14: Ball rolling element defects (30 times magnification)

The microscopic photo clearly shows the tiny (10–55 μm) indentations, which probably caused by the metal particles, that came off from the bearing elements.
